HOLLIDAYSBURG RESERVOIR

NDI I.D. NO: 522

PHASE I INSPECTION REPORT  
NATIONAL DAM INSPECTION PROGRAM

D'APPOLONIA CONSULTING ENGINEERS  
10 DUFF ROAD  
PITTSBURGH, PA. 15235  
JULY 1978

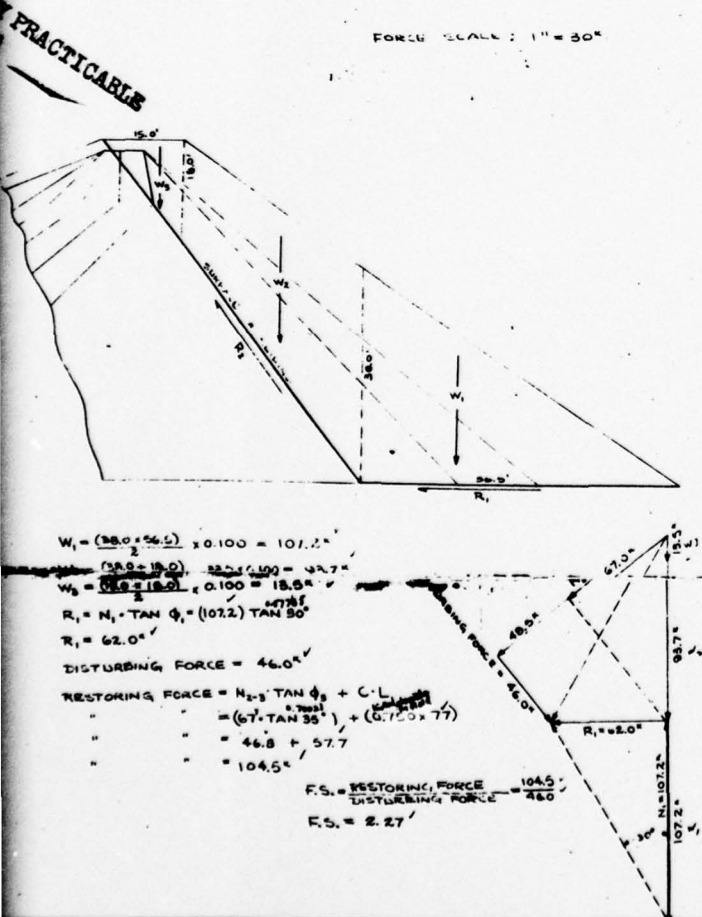
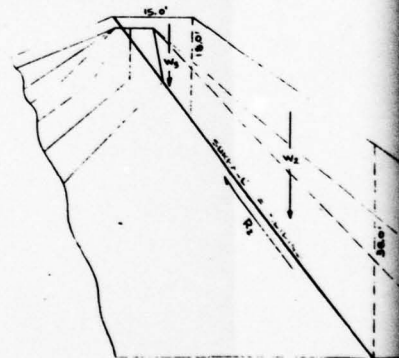
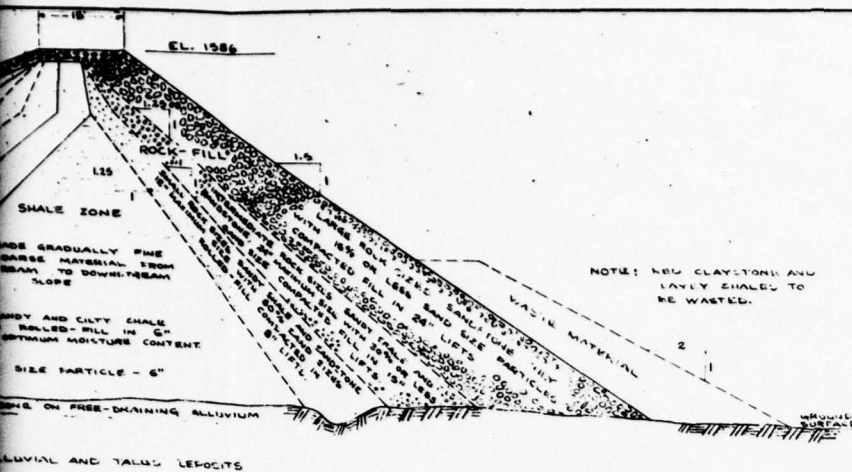
PLATE 8

(2) Embankment. The stability calculations for the embankment are included with design drawings (Plates 8 and 9). The stability of the steeper downstream slope was analyzed for circular and wedge-type sliding surfaces. The minimum computed safety factors were 1.76 for the circular sliding surface and 1.3 for a wedge-type failure. The analysis was based on assumed angles of internal friction of 30 degrees between the rock fill and alluvium based, 40 degrees for rock fill and 35 degrees for the shale fill. The unit weight of all the material was taken as 100 pounds per cubic foot. No reference to through or under seepage analyses was found.

$$F.S. = \frac{21,552.0}{11,553.5} = 1.86$$

STABILITY CALCULATIONS USING  
PLANE SURFACES OF SLIDING.
